DISCOVERING, THE HARD WAY, HOW A HIGH PERFORMANCE COUPLING INFLUENCED THE CRITICAL SPEEDS AND BEARING LOADING OF AN OVERHUNG RADIAL COMPRESSOR—A CASE HISTORY

ABSTRACT

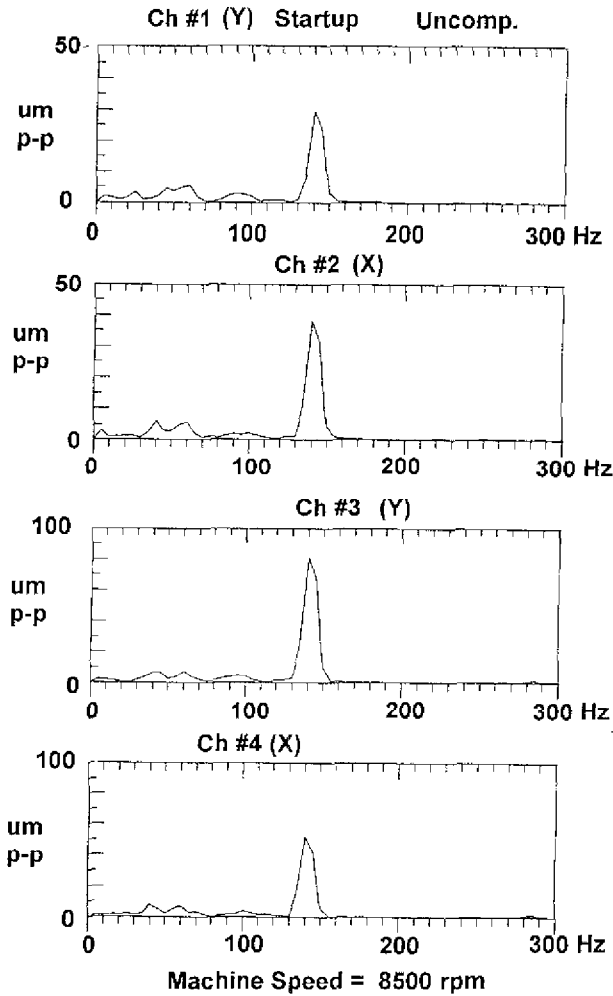
Figure 7. Original "Unbalance" Spectrum.

Initially, the vibration problem presented itself in what appeared to be a relatively straightforward manner. As the test speed of 9450 rpm was approached, the overall direct vibration (uncompensated) rose to values sometimes greater than 100 μm at around 8500 rpm and the tests were aborted. The machine was not operated above

this 8500 rpm limit. The 1× filtered vs direct amplitude was comparable with little or no phase shift. FFT analysis indicated a clear 1× response that was initially interpreted as simply an unbalance condition. A typical set of system responses for these initial observations is shown in Figures 7, 8, and 9.

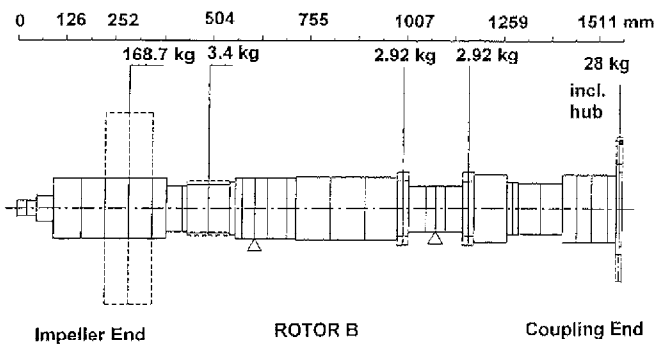
Figure 12. Rotor Model B—With Actual Contract Coupling Weight.

The contract coupling as delivered, however, was a standard design weighing 28 kg at the shaft end. The actual weight was somehow missed in the communication between the compressor and turbine manufacturer, as mentioned previously. The rotor model (rotor B) and forced damped unbalance (using the same unbalance of 1.06 kg-mm at the coupling end) response model and mode shape is shown in Figures 12 and 13, respectively. Calculated critical speeds and the amplification factor are shown in Table 1, column B. The first critical speed was at 3800 rpm and the second was at 9100 rpm, very near the problem speed on the test stand!

But, even though the observed test resonance was very likely related to the new rotor (rotor B) model second critical, the rotor had been calculated to be critically damped, with an amplification factor of 1.2 (Table 1). Damped Eigen value stability analysis showed no problems. Log decrement values were well in the stable range. The high amplification was completely unexpected and more investigation was necessary.

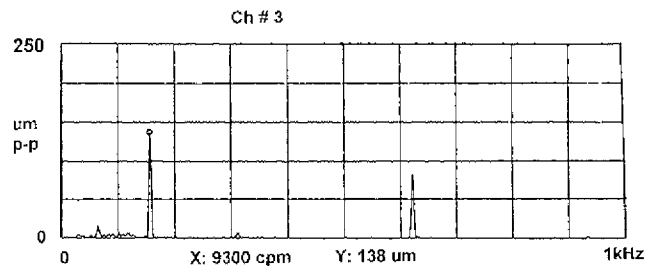
Figure 14. "Resonance" Spectrum.

through the resonance. The observed vibration magnitude was up to 250 μm with a corresponding phase shift. This result appeared to be only the initial onset of the resonance. The machine could be run up to 9300 rpm, with stable amplitudes at 40 μm to 60 μm with no phase shifting. But once the speed was increased above 9400 rpm, the amplitude would increase dramatically. Depicted in Figures 14, 15, and 16, are the nature and magnitude of the vibration.

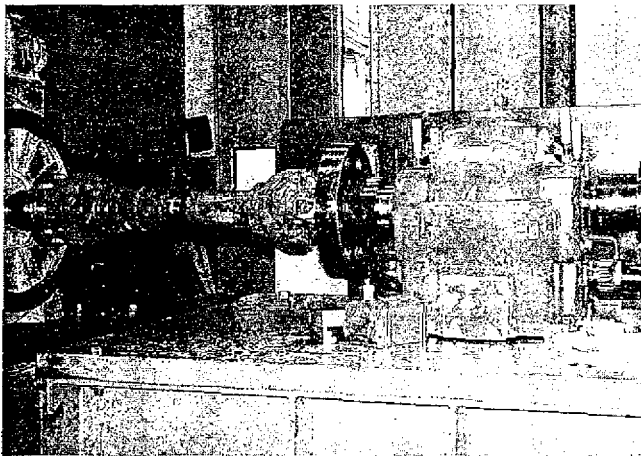
Figure 17. Original Gearbox and Cardan Shaft.

- *Cardan shaft*—The Cardan shaft (Figure 17) was also theorized as providing a source of the vibration. Following checks of the original unit balance records that showed an acceptable residual unbalance, another unit of approximately double the mass and physical size was substituted, with no significant influence. Therefore, this component was eliminated from the discussion.

- *Test gearbox*—The test gearbox was suspected as inducing the vibration. The original unit, also depicted in Figure 17, was a double helical unit of 1:3.11 ratio used to increase the available output speed of the DC motor. The gearbox generated some relatively high vibration readings. However, attempts to isolate this source of the resonance were inconclusive following disassembly and inspection of gearing and bearings, mechanical runout measurements and rebalancing of both input and output shafts, and gearing. Analytical methods incorporating the characteristics of the output pinion into the lateral/torsional model also showed no significant influence. A high level subsynchronous vibration (0.45 \times to 0.49 \times) was eventually isolated within the output shaft

bearing system. This gearbox was replaced with a larger capacity unit of 1:5 ratio that would allow operation at the full operating speed of 10,500 rpm and is shown in Figure 18. There was no measurable change to the vibration characteristics. Measurements of radial and axial vibrations, thermal growth, and mechanical runouts on input shafts, output shafts, bearing systems, and casing provided no relevant information. Due to the lack of system response following the gearbox replacement, this component was eliminated from the investigation.

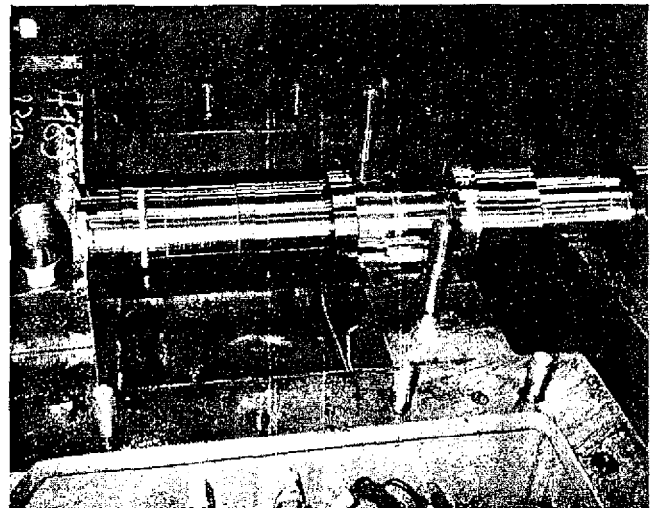
Figure 19. Bearing Pedestal.

- *Overhung bearing pedestal design*—A possible structural resonance was theorized within the overhung bearing pedestal design. The housing is a horizontally split design that allowed for impact testing of the unit in various stages of assembly and disassembly. However, the webs carrying the bearing systems are quite massive; therefore, the resultant Campbell diagrams showed no significant resonant frequencies. The fasteners mounting the bearing caps were eventually modified to provide a stiffer bearing assembly, but the effect was not quantifiable. This assembly is shown in Figure 19.

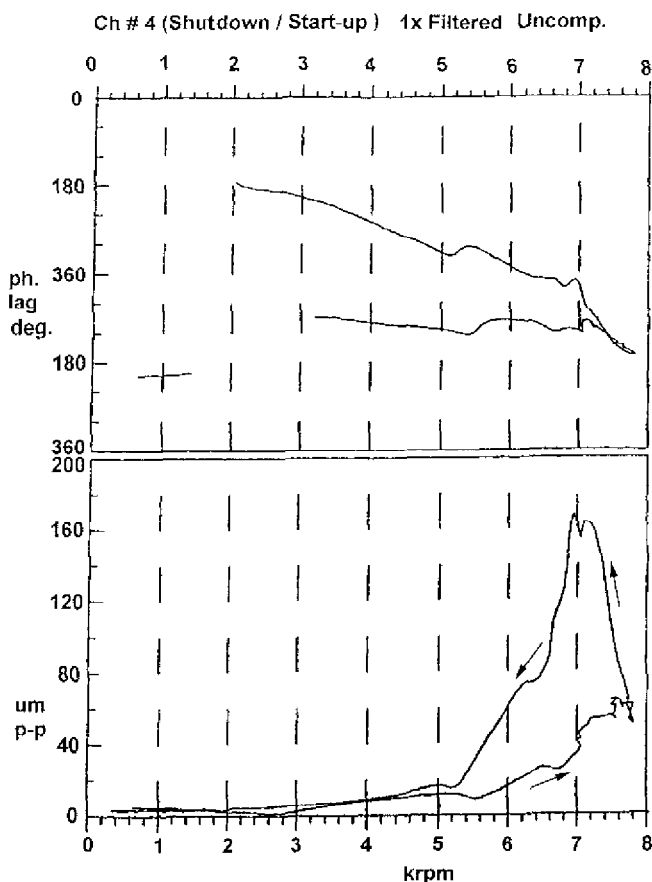
Figure 21. Bode Plot of Original Test Coupling with First Trial Weight.

It should also be noted here that there appears to be jump phenomena depicted on Figure 21, which indicates a highly nonlinear condition. However, it was assumed at the time, possibly incorrectly, that the odd vibration behavior was related to the unbalance in the weight ring assembly.

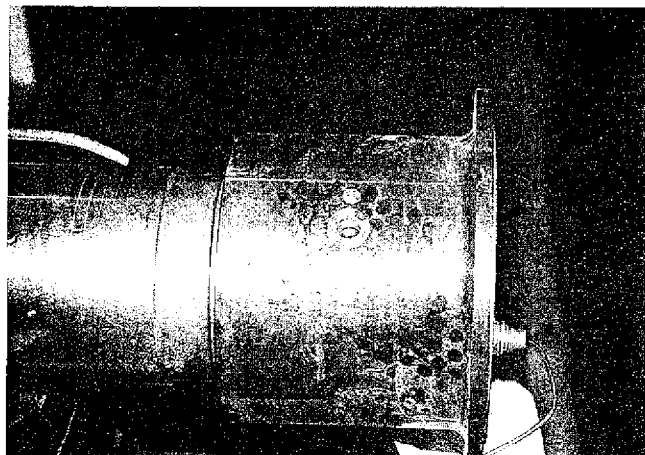
Figure 27. Unbalance in Original Contract Rigid Hub.

The contract coupling, which had been returned to the factory for inspection, had significant unbalance (230 g-mm) in the rigid hub; unbalance that was not reflected on the original balance report. Apparently, permanent field corrections (drilled holes in the hub body) had been made to the rigid, to account for the unbalance introduced in the hub when a threaded plug was inserted into a hydraulic port hole for dust/contaminant protection (Figure 27).

Rotor response to unbalance calculations were done to see if this rigid hub unbalance could have caused the severe vibration levels. The results were marginal; the unbalance in the rigid could have contributed to the problem, but it was probably not the only cause.

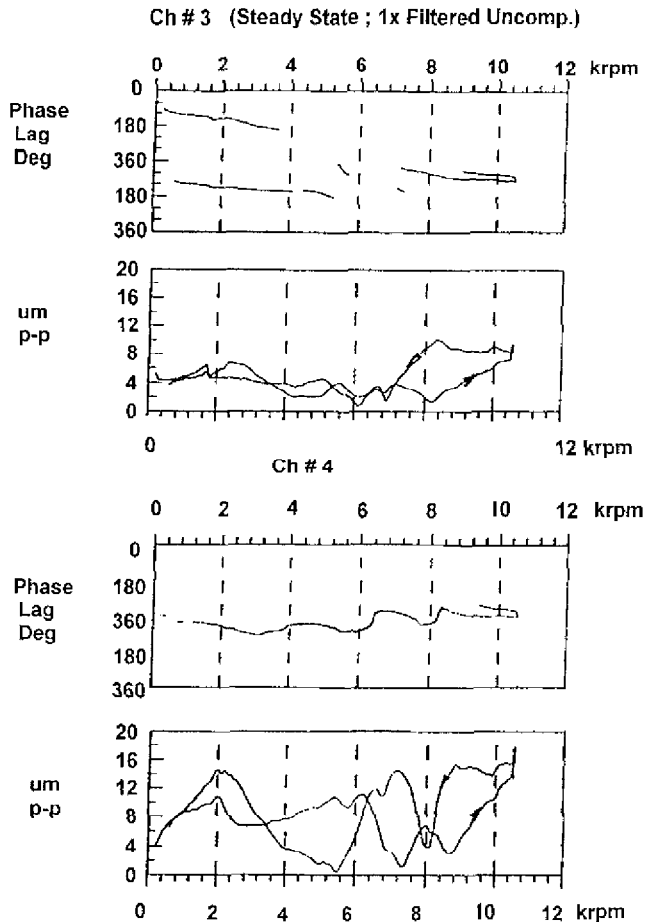
Figure 29. Final Successful Run Bodé Plot.

After the mechanical test run with the heavy coupling arrangement (rotor E), it was reported “... the maximum direct (vibration amplitude) values (were) $< 25 \mu\text{m}$. Therefore, the sun is shining today!!!” The final run values are shown in Figure 29. The compressor was shipped shortly thereafter for mechanical linkup with the gas turbine.
