DISCOVERING, THE HARD WAY, HOW A HIGH PERFORMANCE COUPLING INFLUENCED THE CRITICAL SPEEDS AND BEARING LOADING OF AN OVERHUNG RADIAL COMPRESSOR—A CASE HISTORY

ABSTRACT

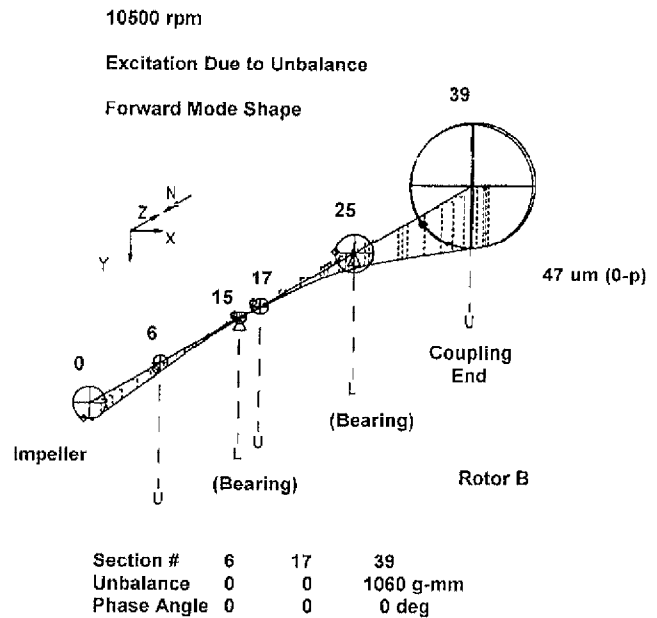
Figure 13. Unbalance Response Mode Shape for Model B.

But, even though the observed test resonance was very likely related to the new rotor (rotor B) model second critical, the rotor had been calculated to be critically damped, with an amplification factor of 1.2 (Table 1). Damped Eigen value stability analysis showed no problems. Log decrement values were well in the stable range. The high amplification was completely unexpected and more investigation was necessary.

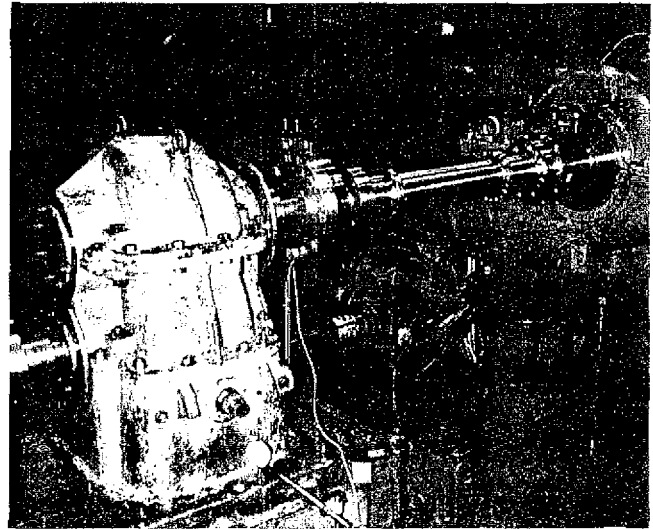
Figure 18. Replacement Gearbox.

- *Test gearbox*—The test gearbox was suspected as inducing the vibration. The original unit, also depicted in Figure 17, was a double helical unit of 1:3.11 ratio used to increase the available output speed of the DC motor. The gearbox generated some relatively high vibration readings. However, attempts to isolate this source of the resonance were inconclusive following disassembly and inspection of gearing and bearings, mechanical runout measurements and rebalancing of both input and output shafts, and gearing. Analytical methods incorporating the characteristics of the output pinion into the lateral/torsional model also showed no significant influence. A high level subsynchronous vibration (0.45 \times to 0.49 \times) was eventually isolated within the output shaft

bearing system. This gearbox was replaced with a larger capacity unit of 1:5 ratio that would allow operation at the full operating speed of 10,500 rpm and is shown in Figure 18. There was no measurable change to the vibration characteristics. Measurements of radial and axial vibrations, thermal growth, and mechanical runouts on input shafts, output shafts, bearing systems, and casing provided no relevant information. Due to the lack of system response following the gearbox replacement, this component was eliminated from the investigation.

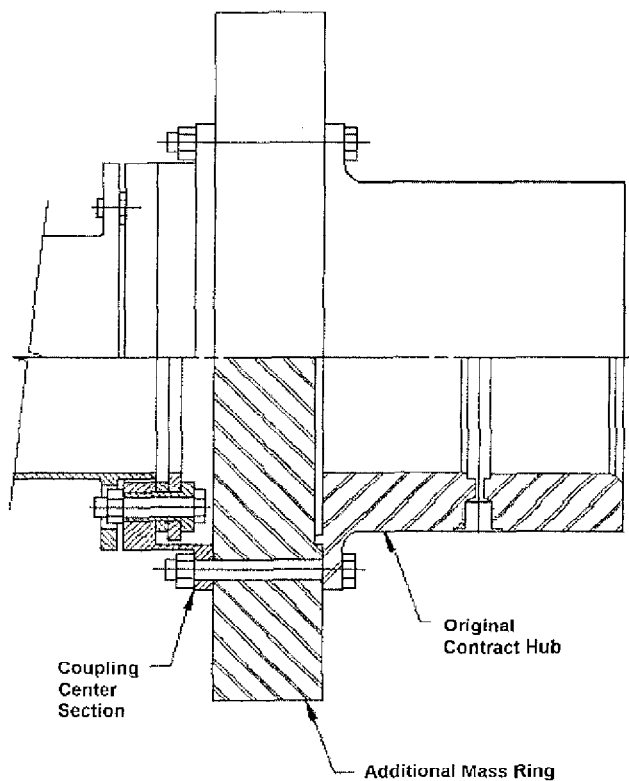
Figure 20. Original Test Coupling with First Trial Weight.

To check the original lateral model, a test was devised whereby an additional mass, a weight ring (Figure 20), was added to the contract coupling hub. Although the results (Figure 21) were promising, in that the resonant center frequency was decreased to 7000 rpm, the amplification factor was still too high (between 9 and 10). The ability to manufacture the ring to acceptable tolerances (for balance purposes) was cited as part of the reason for the high amplification factor. In other words, in order for a coupling/weight ring to run properly, tight tolerances on the locating diameters between the coupling hub and the trial weight were required, but were not achieved. It was at this point that thought was given to manufacturing a new half coupling that had the extra weight used in the original rotor lateral analysis.

It should also be noted here that there appears to be jump phenomena depicted on Figure 21, which indicates a highly nonlinear condition. However, it was assumed at the time, possibly incorrectly, that the odd vibration behavior was related to the unbalance in the weight ring assembly.

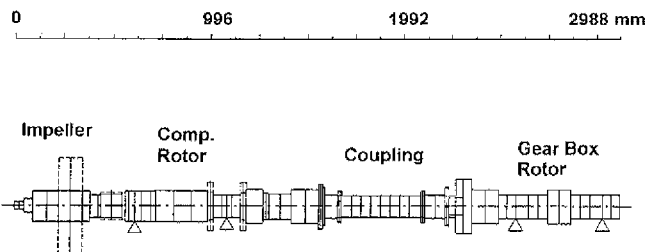
Figure 22. Test Train Model.

Normally, the rotor lateral analysis is modelled assuming the coupling can be divided into two distinct half sections, and that each rotor is isolated from the other by the coupling flexible elements. A more thorough test stand rotor analysis (with the compressor and the gearbox rotor) was done using the coupling flexible element bending moments and lateral stiffnesses (Figure 22), but no significant difference was calculated between the models.

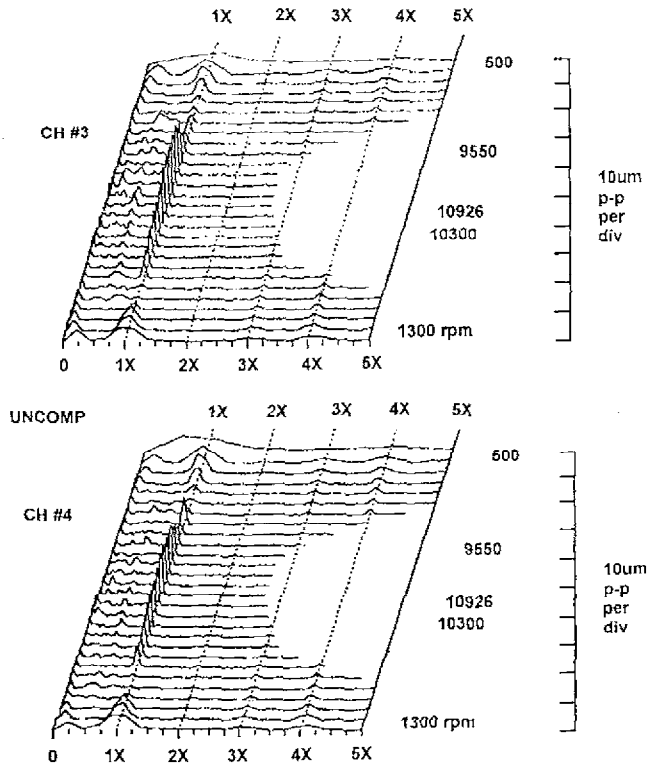
Figure 24. Shop Test Coupling Waterfall Diagram.

This arrangement was able to run successfully. The overall vibration was within API levels, there were no phase changing effects at speeds up to 10,900 rpm, and there was no significant amplification factor during shutdown (Figure 24). But, as before, there were questions about the validity of using these test results to deduce that the contract coupling was the problem. First of all, the couplings were completely different designs with different physical characteristics.

It can be seen here that the overhung mass of a coupling can have a significant effect on rotor critical speeds, as noted by Wolford [5]. The effect of the reduced overhung test mass was not only to raise the second critical speed, but also to raise the ratio of the second to first critical, as predicted by Weaver [6].

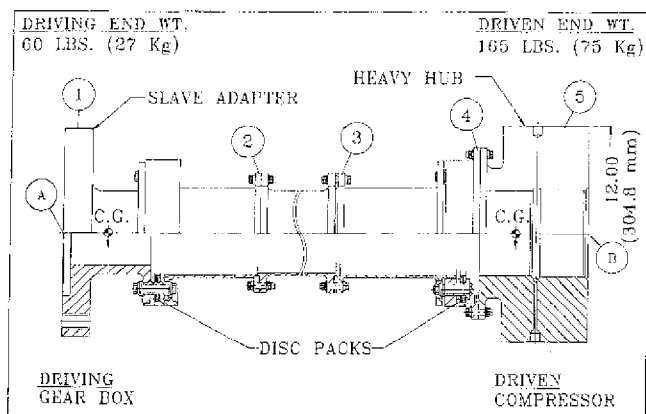
Figure 28. Final Test Coupling with Contract Heavy Hub with Indication Points.

The final test series at full operating speed included the new “heavy” 75 kg half coupling mated to the rest of the test stand coupling (Figure 28), and significant bearing modifications.

This was an important inspection, just as important as the coupling balancing operation. For example, if it were determined from indicator readings that the hub body (measurement 5 in Figure 28) ran out 0.002 in (51 μm) TIR to the center of shaft rotation, that would mean that the coupling’s axis of rotation was shifted 0.001 in (0.002/2) from the center of shaft rotation. This is equivalent to 1000 micro-in (25,400 μm), which would be 20 times the API 671 [3] assembly balance tolerance of 4W/N (50 μm). This topic is covered in the literature [4].

There were a few things done to ensure that the coupling operated well balance-wise. The main focus of these other efforts was on installation. Specific instructions were given to the test floor to turnover the coupled rotors before the test and check the runouts of key diameters on the installed coupling (Figure 28) to ensure that they were within the values of Table 3.
